PSCE Newsletter

Pakistan Society of Civil Engineers

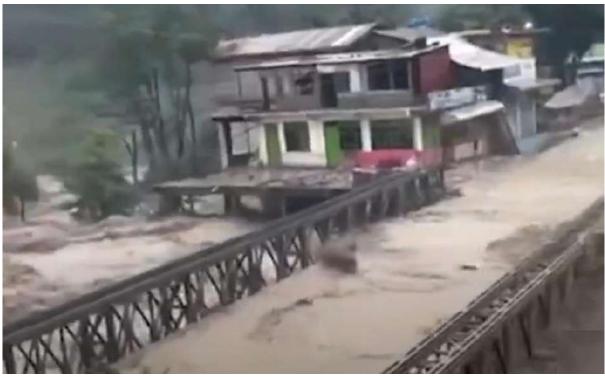
Figure 4: Frame-1, Frame-1, Water flowing across the deck

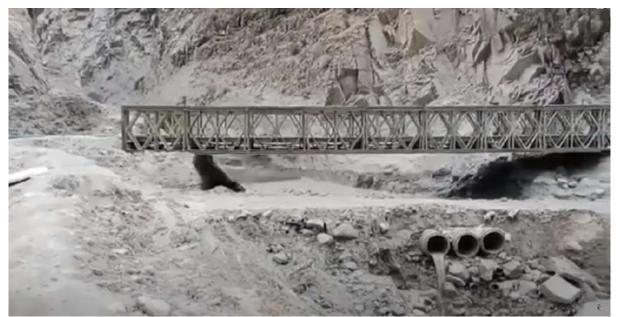
Figure 5: Frame-2, Bridge dislocated from its abutment

The bridge was uprooted from the abutment, as a rigid body as it was battered by the impact caused by violent high-speed flood water laden with charge of boulder, gravel, earth and wood debris. The impact forces were actin transverse to the bridge axis.

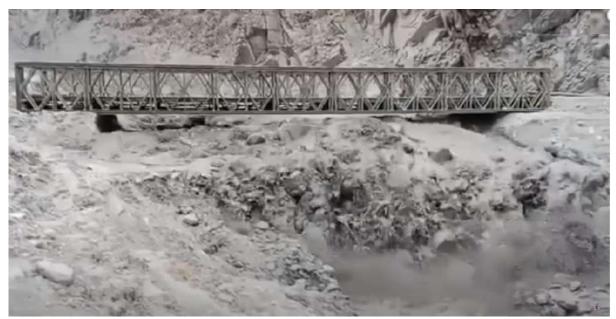
Figure 6: Frame-3, Bridge adrift

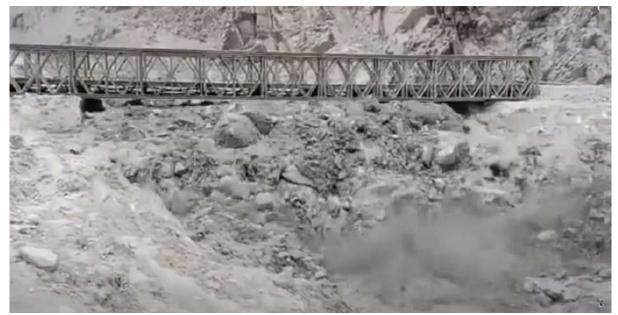
Figure 7: Frame-4, Bridge moves farther away from the original position and sitting on debris

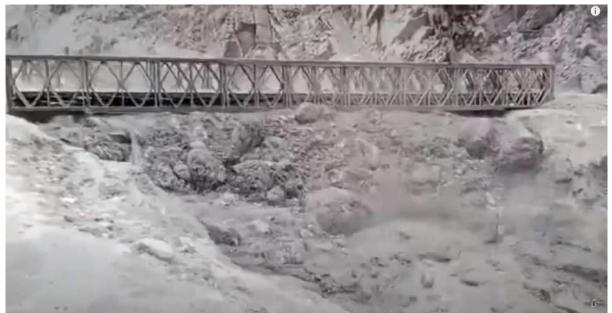
Figure 8: frame-5, Bridge moves still farther away from the original position and sitting on debris

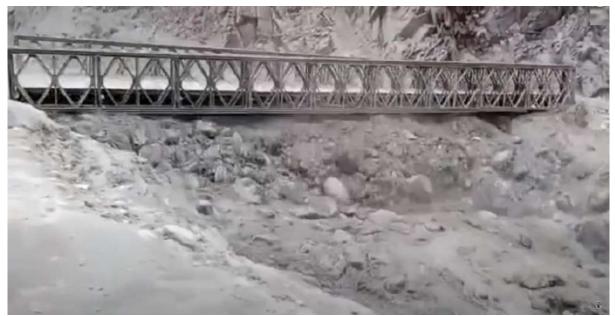
Figure 9: Frame-6, Bridge very far away from the original position and about to lose its support from debris

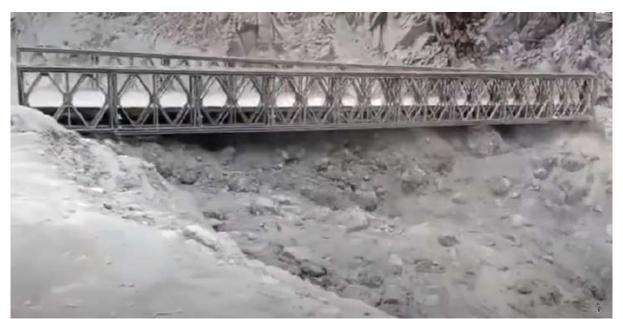
Figure 10: Frame-7, Bridge quite far away from the original position and has almost completely lost its support

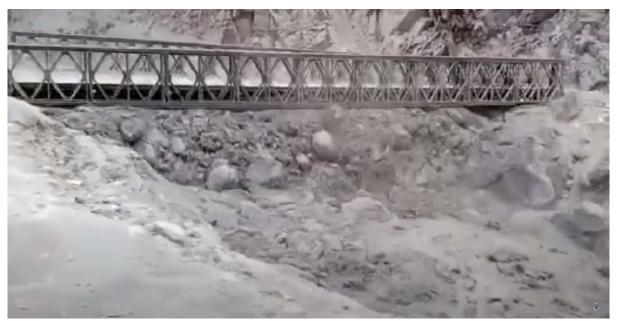
Figure 11: Frame-8 Bridge very far away from the original position and about to lose its support on earth

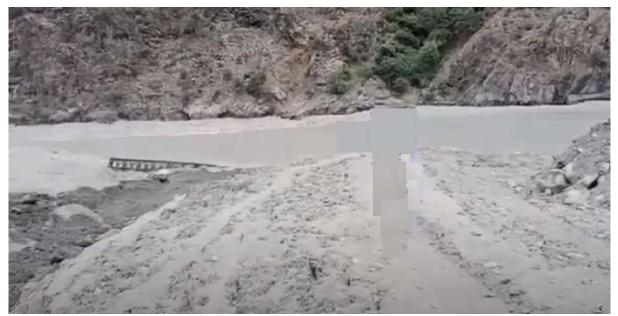
Figure 12: Feame-9, Bridge afloat in water

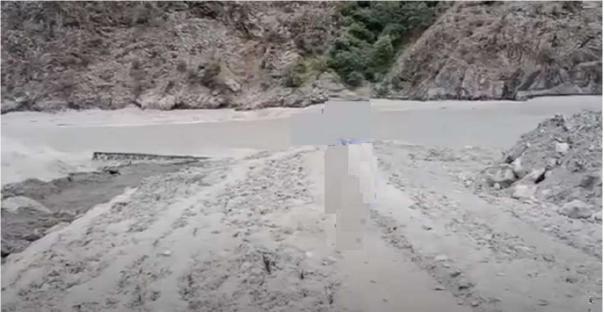
Figure 13: Frame-10, Bridge afloat in water, with its top partially visible

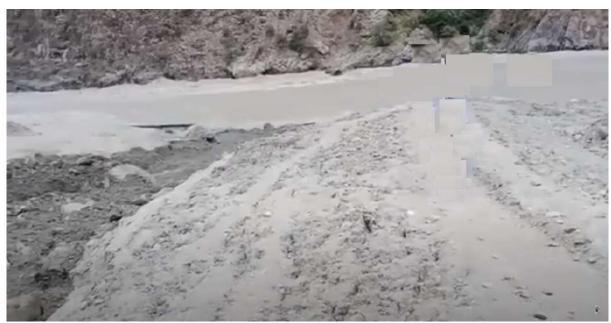
Figure 14: Frame-11, Sinking bridge, barely visible
