Torrential Rains Lead to Partial Collapse of Bridge in KSA

PSCE Newsletter

Pakistan Society of Civil Engineers

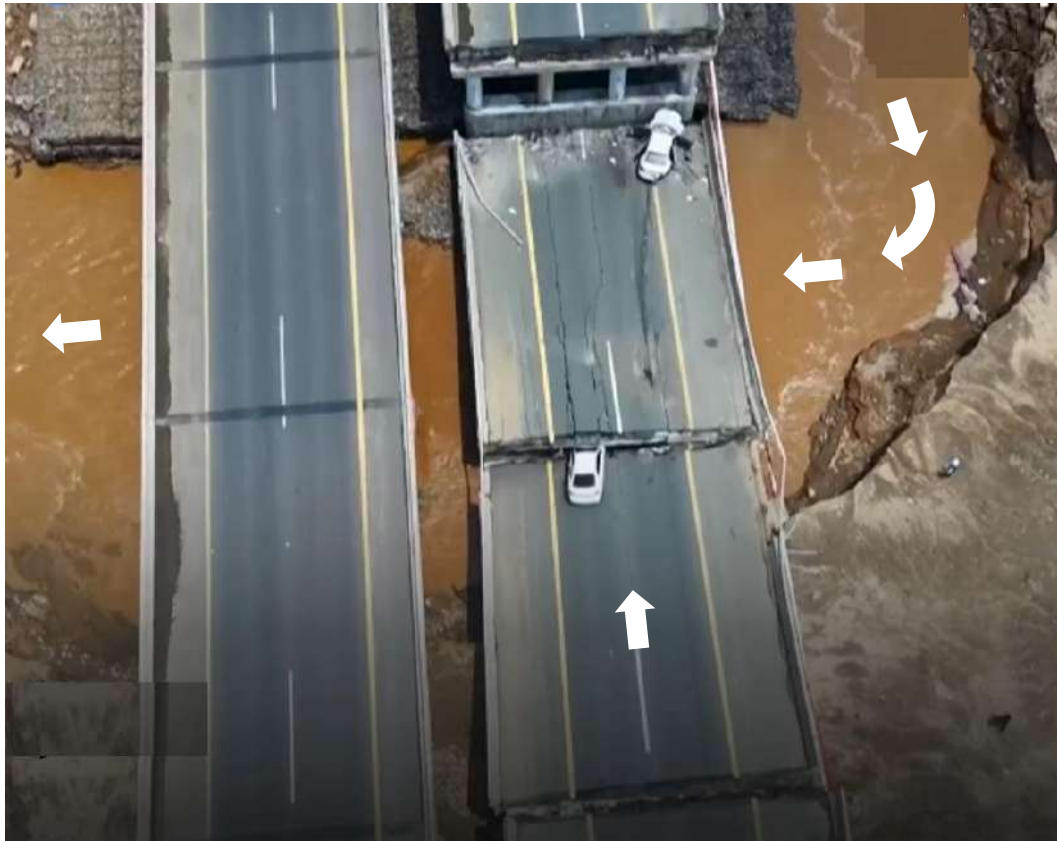
FIGURE 3: AN AERIAL CLOSE-UP OF THE COLLAPSED DECKS SHOWING DAMAGED VEHICLES AND THE DECKS

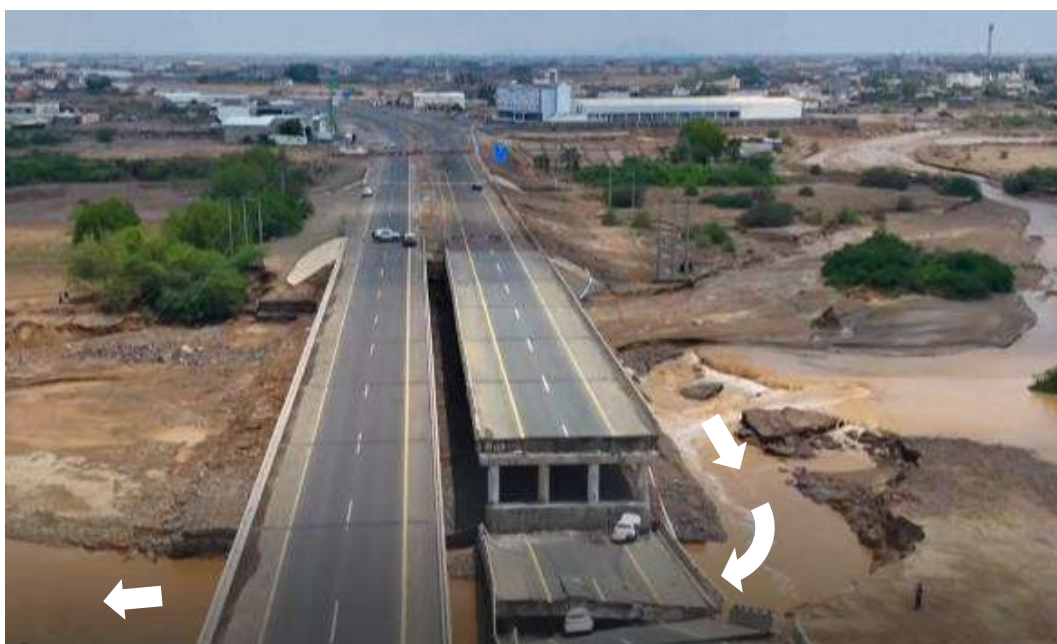
FIGURE 4: A PERSPECTIVE VIEW OF THE COLLAPSED BRIDGE

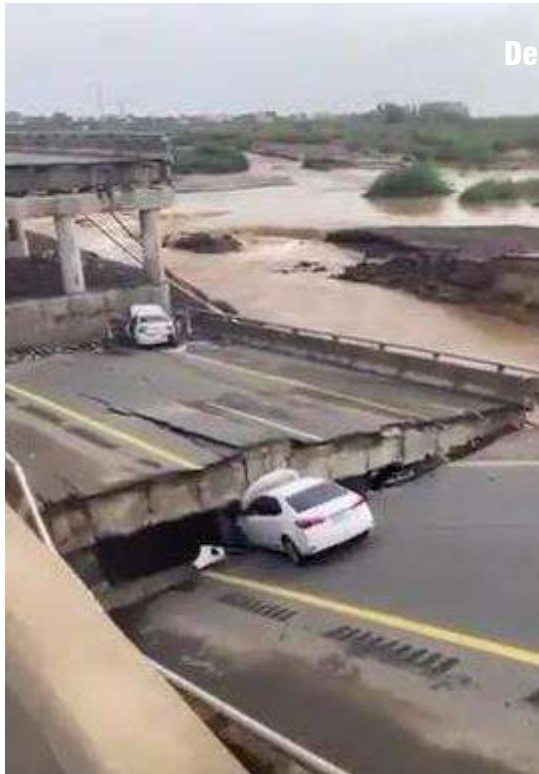
FIGURE 5: TURN IN THE STREAM CENTERLINE, COLLAPSED DECKS AND VEHICLE IMPACT

The failure of the bridge followed ten hours of heavy rain. The centreline of the stream had a sharp turn at the point it crossed the bridge axis.

High-velocity water, at the turn, led to heavy turbulence in the water causing inundation of the soil, finally resulting in the scouring of the upstream foundation system, located within the stream and serving as the support of one carriageway. The foundation lost support to the ground and collapsed. Two spans of this carriageway, resting on the damaged foundation, lost their support at this common edge and fell off. The soil is believed to be non-cohesive sandy material.

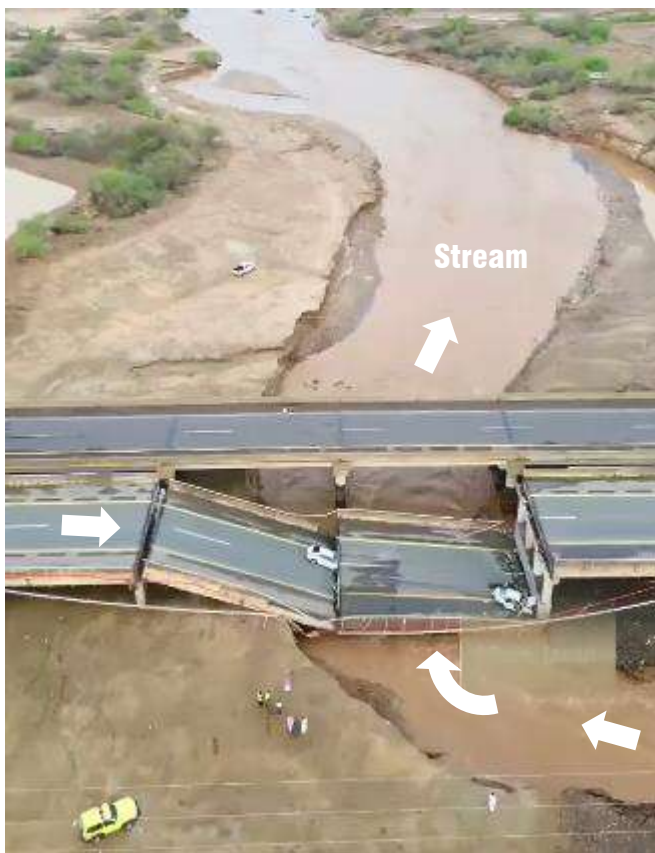
FIGURE 6: AN AERIAL VIEW OF THE COLLAPSE BRIDGE

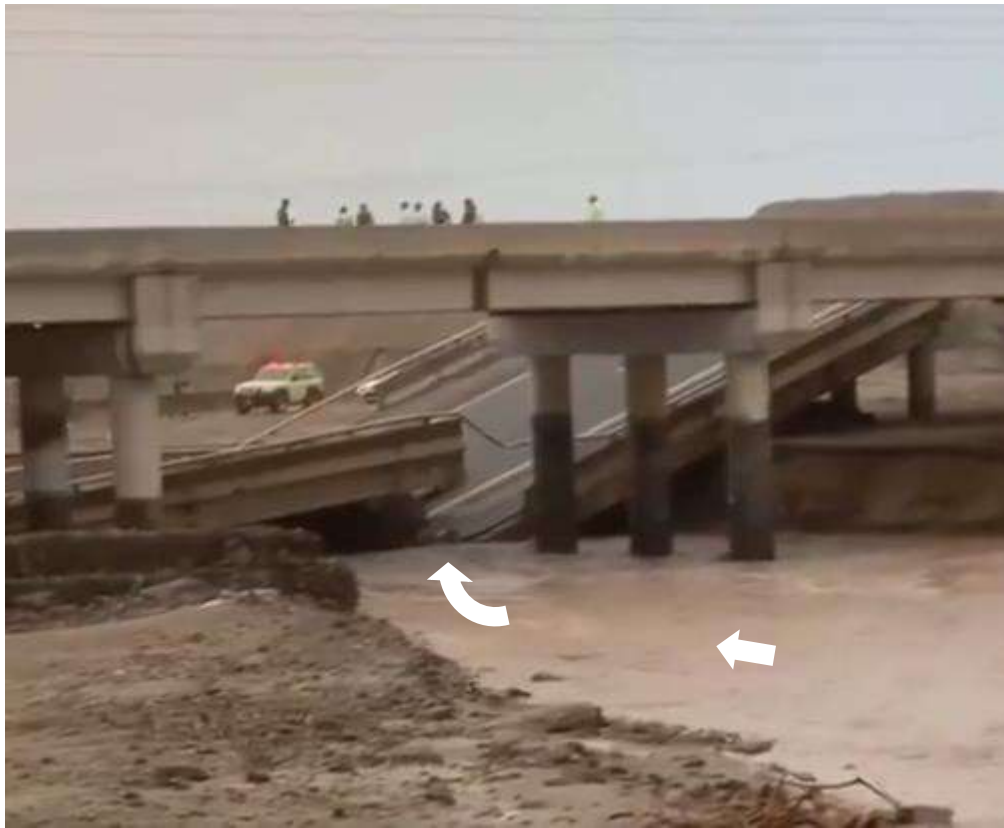
FIGURE 7: AN ELEVATION VIEW OF THE COLLAPSED DECKS

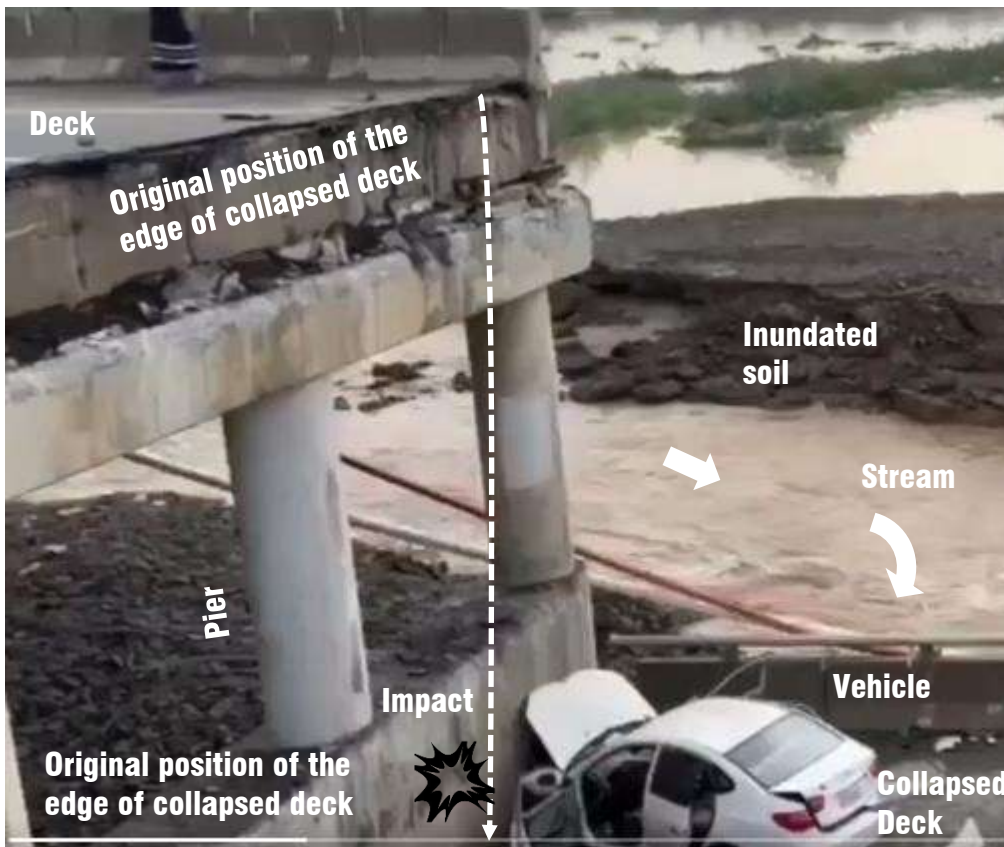
FIGURE 8: VEHICULAR IMPACT

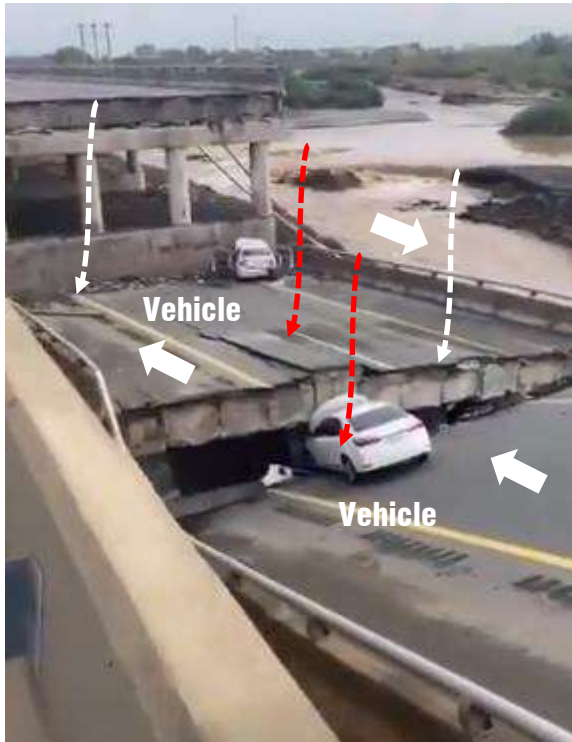
FIGURE 9: FINAL AND ORIGINAL POSITIONS OF COLLAPSED DECK SYSTEM

One span retained its shear connection at the far end while the other pier could not do so, possibly, as a result of the vibrations caused by the impact.

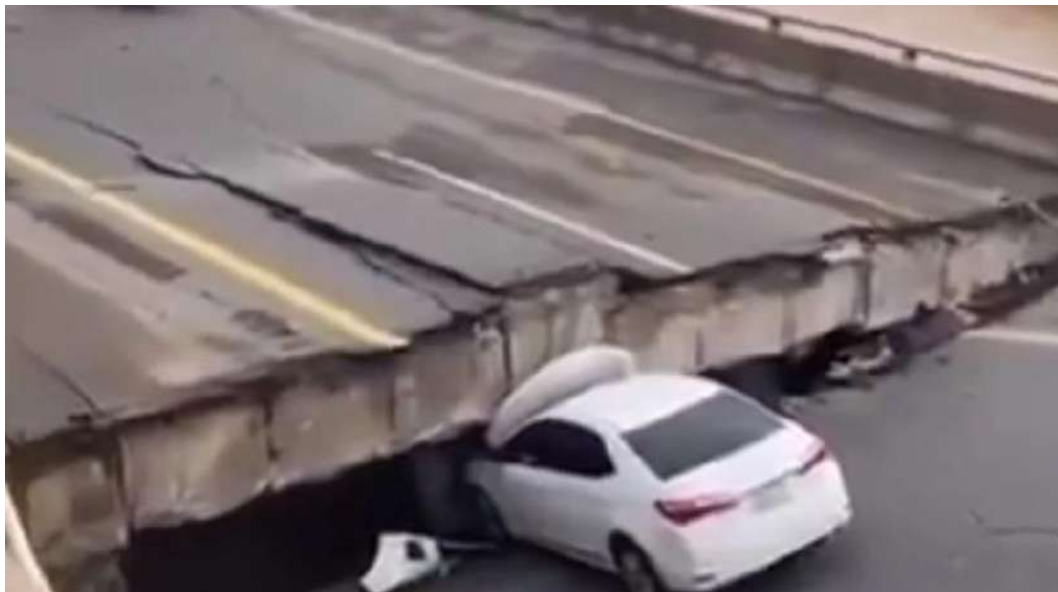
FIGURE 10: BADLY DAMAGED DECK OF THE COLLAPSED SPAN
